# L2 Newsletter

April 2011 : Issue No: 4

## Initial Analysis of the Fukushima Dai-ichi Nuclear Accident

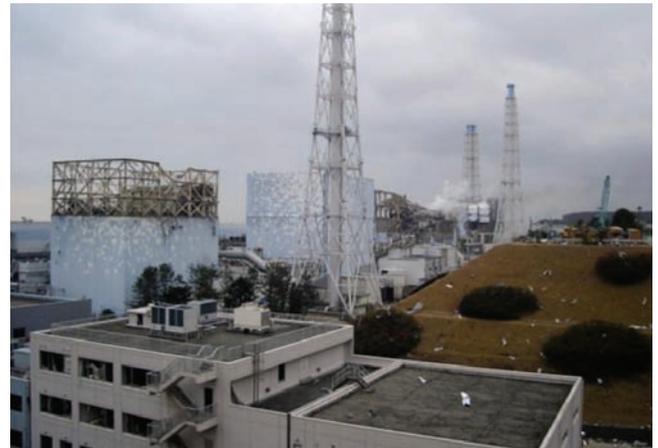
*Unit 1 foreground, Unit 2 relatively undamaged structures, Units 3 and 4 background similar damage to Unit 1 (© TEPCO)*

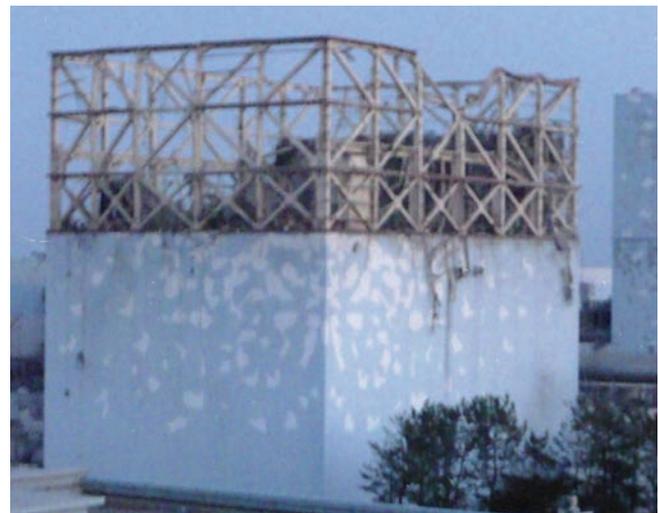
*Unit 1 showing damage to secondary structures following hydrogen explosion on reactor service floor (© TEPCO)*

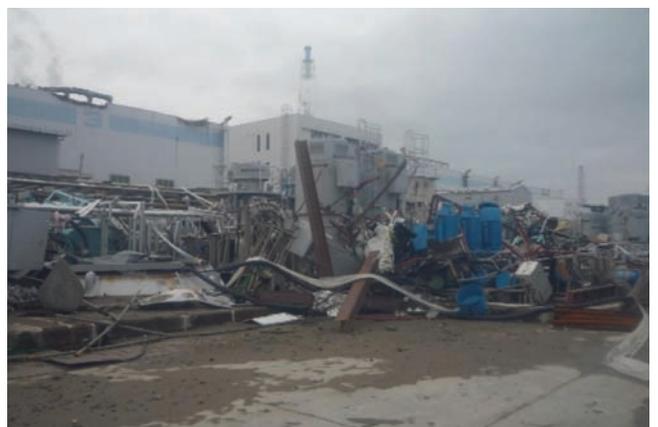
*Damage at Fukushima Dai-ichi site following the tsunami (© TEPCO)*

- The tsunami inflicted considerable damage to key plant and systems on site including key emergency safety systems such as the back-up diesel generators which had a catastrophic effect on decay heat cooling. It would appear that greater physical protection of these systems was needed and greater plant redundancy. It would also appear that in the case of site is susceptible to flood risk that there is a need for standby back-up power, via diesel generator and/or battery power, at a suitable elevation above the flood risk level. Consideration should also be given to placing back-up standby power at a suitable distance from the reactor buildings and possible positioning fuel sources separate from these. Whilst recognising the extreme flood outcome placed by the tsunami, it appears that greater understanding of the potential for flood proofing this type of back-up plant in the future is needed.
